A History of the Middlesex County Gaol at Haddam, Haddam Historical Society  
Observations of Conditions at the Middlesex County Gaol, Architectural Workshop

OBSERVATION OF CONDITIONS  
AT THE  
MIDDLESEX COUNTY  
GAOL  
SAYBROOK ROAD  
&  
JAIL HILL ROAD  
HADDAM, CT.  
FOR  
TOWN OF HADDAM  
JAIL COMMITTEE

ARCHITECTURAL  
WORKSHOP

28 OCT 08

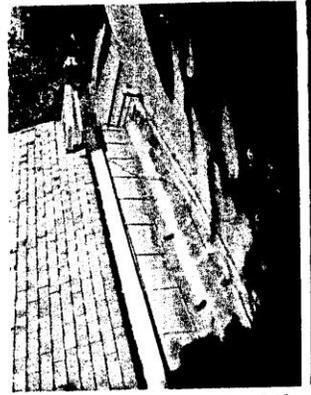
12

The sheathing of the roof is wide board but not spaced, a close look through the board joints revealing remnants of what appears to be a flat seamed tin roof underneath the current asphalt shingles.<sup>11</sup> The addition of the Administrative Building creates a condition where the entire west side of the roof from the ridge pitches against the new building. Currently a

sheet metal pan pitched from the middle of the building to each roof edge conveys water off the roof.<sup>12</sup>

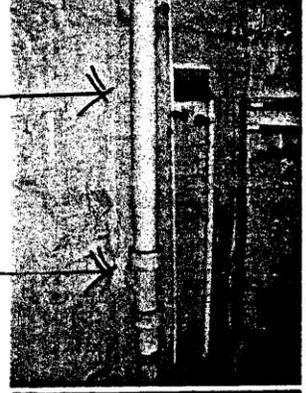
24

This addition appears to have been built against the Workhouse/ Side Entry and subsumed in the more recent Kitchen addition. The structure appears to be board formed concrete roof/ceiling and walls. The floor is concrete slab set below current grade. On the north wall is evidence of a former opening into the cell block, and on the east wall is an infilled opening into the Side Entry addition.<sup>24,25</sup>

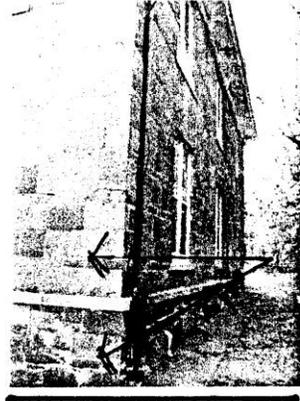
30

The walls of the building are cut and coursed stone on the north and west elevations above the watercourse and random coursed on the alternate facades, and below the watercourse.<sup>30</sup> The north side doors/windows on the first floor have all been replaced. Basement windows on this façade have also been closed in. The west façade contains two probable former openings at the first floor level indicated by a lintel and sill.<sup>31</sup> Both are well concealed. One aligns with a probable window location the other is an adjacent door. The south façade suffers from the addition of an open steel exit stair, and the Kitchen addition. The second floor door to the exit stairway appears to be a former window location, and the third floor exit is the probable dormer addition previously described. Finally the east façade abuts the existing buildings, with only the third floor with much exposure. Still, two former openings at the second floor are visible. Both have been infilled with concrete block and are difficult to detect from the street.<sup>32</sup>

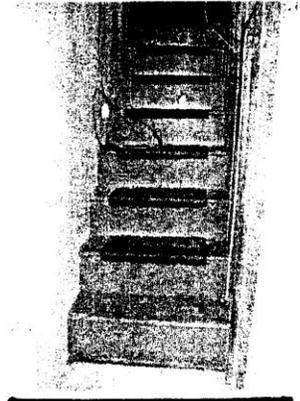
33

The second and third floor interiors retain much of their original woodwork. Generally, the windows & window trim and door casings are original. Baseboards require further investigation as they all currently appear incongruous with the quality of the original trim. Additionally, crown mouldings are noticeably absent. Much of the original work was furred out and covered with additional finish materials. Generally, the center hall and door locations, the stairway, and most of the existing partitions are original to the building. The original walls and ceilings on both floors are plaster on 3/8" lath attached to the studs with machine cut nails. Most of the ceilings had been furred down with additional finish materials now removed. The first floor appears highly modified, although the northwest chamber seems to be an original room and the stair hall (albeit cut off) exhibits original millwork. The basement stair appears to be in its original location, and at the southwest corner of the building a narrow wood framed stair rises to the second floor. Though it is currently floored over, the stair looks to be original.<sup>33</sup>
